SCHWENK BETONFABRIEK – BERNBURG – DUITSLAND

In 1992 werd de nieuwe betonfabriek **SCHWENK** in Bernburg beschermd met **ZINGA**.

Dit is het inspectieverslag van 18-03-2003 van **Mr. Schwarz** van de firma **AGESO**, met betrekking tot zijn bevindingen gedurende zijn bezoek in Februari 2003 : **10 jaren na de ZINGA applicatie.**

Cement factory SCHWENK at Bernburg /East Germany / Inspections on ZINGA after over 10-years after application and submission under rough production conditions.

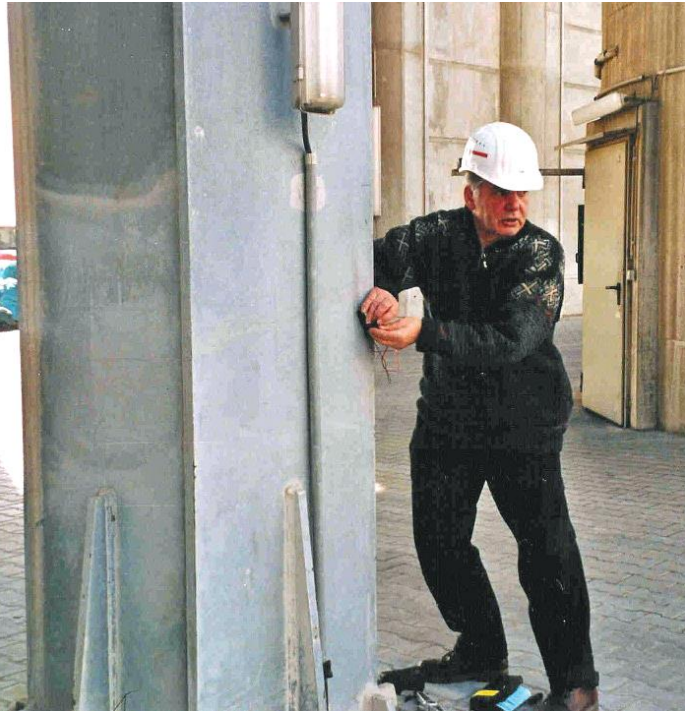
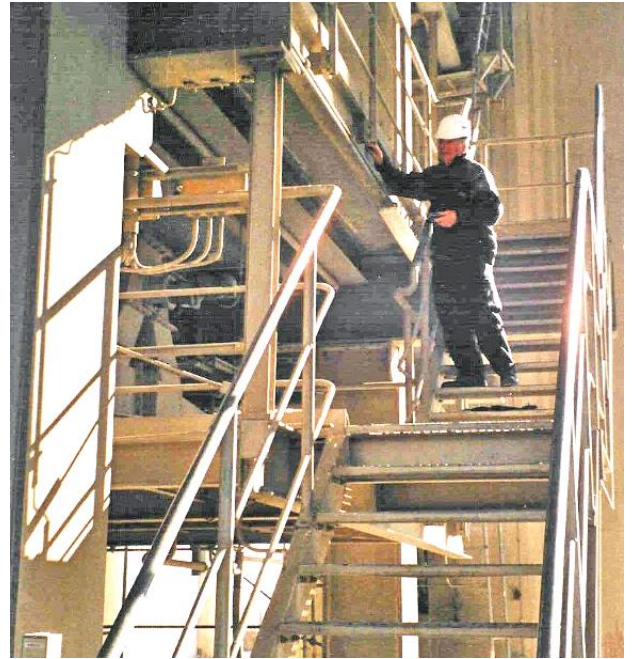
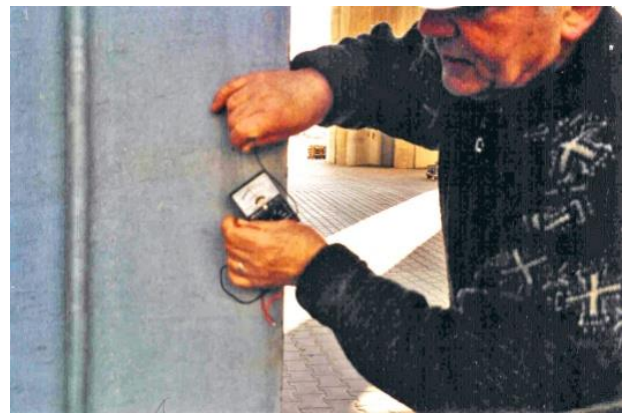
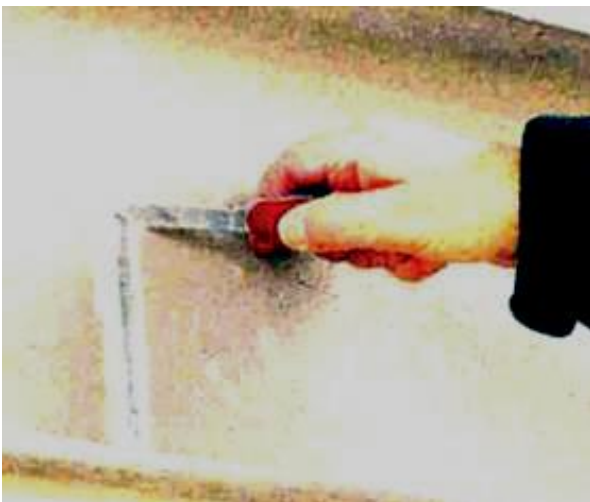
Aan de weer en wind blootgestelde kant van de fabriek, waar abrasieve elementen en regen het oppervlak wassen, verminderde de **ZINGA** laagdikte van 120 μm naar 70 μm .

Dit komt neer op 5 μm per jaar, wat verrassend goed is in deze strenge milieuomstandigheden.

On the weather-side no such dirt could be detected on top of the ZINGA layers, where abrasive media, rain, snow etc. washes the surfaces clean. Refer to photograph no 5 and one finds darkish grey surfaces of ZINGA. At no situation could the beginning of rust be detected. At no places were cracks or brittle spots discovered. The layers of ZINGA at each and every spot appeared to be extremely hardened.

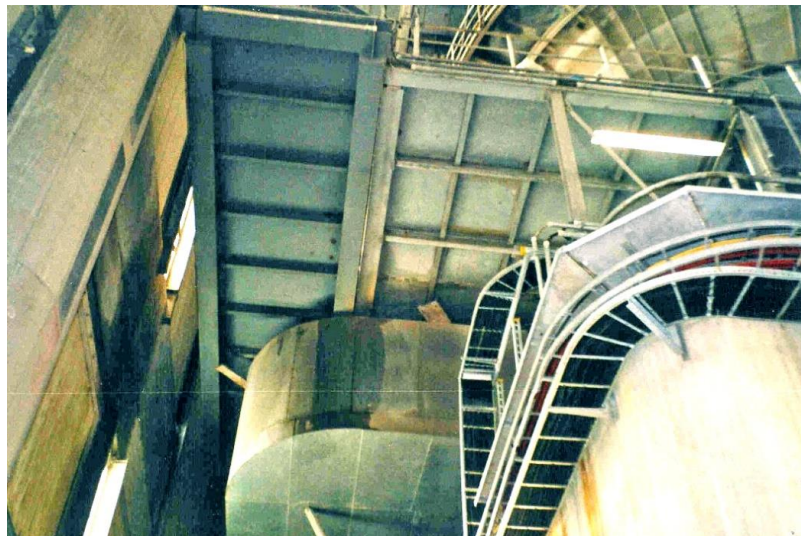
Het donkergrijs op deze hoge installaties is **ZINGA**, nog steeds in perfecte staat.
Het lichtgrijze is warme galvanisatie, waar beginnend roest zichtbaar is.
