## STORAGE TANK - STROM- UND HAFENBAU HAMBURG PORT AUTHORITY – GERMANY

In 1989 an oil storage tank was protected with **ZINGA** by the engineering office of **Strom- und Hafenbau Hamburg**, the Port Authority.

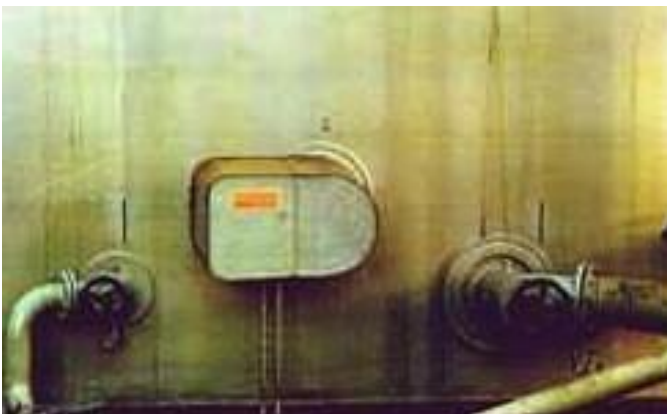
Below you see a detail of the condition of the tank in 1999.

Since 30/08/89 until today there was no deficiency in quality on the existing sample surface treated with the supplied product :  
AGESO KALTZINK HS 300 which had to cope with a severe industrial climate.  
Only some small, mechanical damage was visible, but this was due to a lot of manipulation in between, such as mantling etc. and not due to the coating system itself.

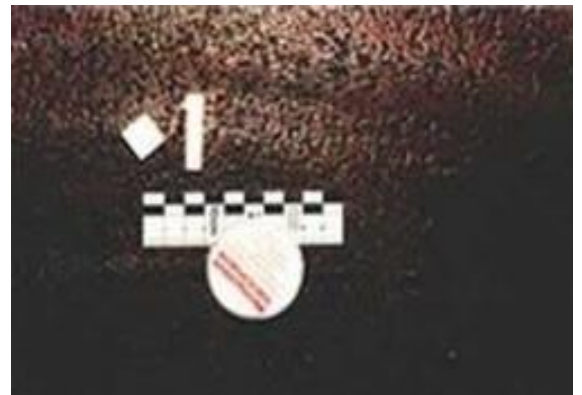
Detail of the surface  
before treatment in 1989

System:  
ZINGA 2 x 60  $\mu\text{m}$  DFT  
Topcoat 1 x 40  $\mu\text{m}$
