IMMERSED PIER LEGS – KILLYBEGS FISHING PIER – IRELAND

The application of **ZINGA** on the pier legs at Killybegs Harbour was done in the summer of 2000.

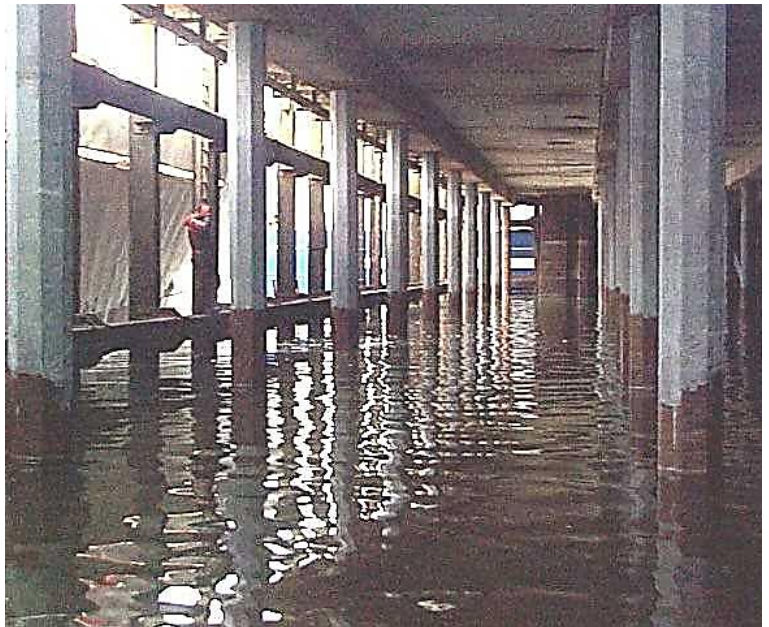
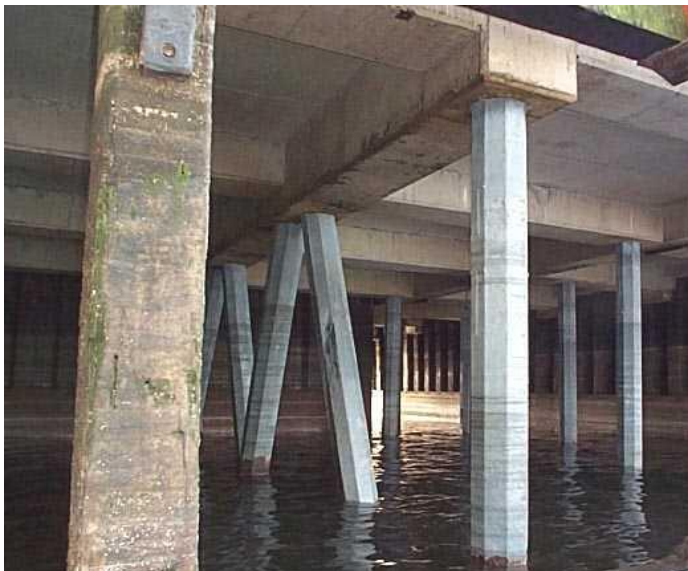
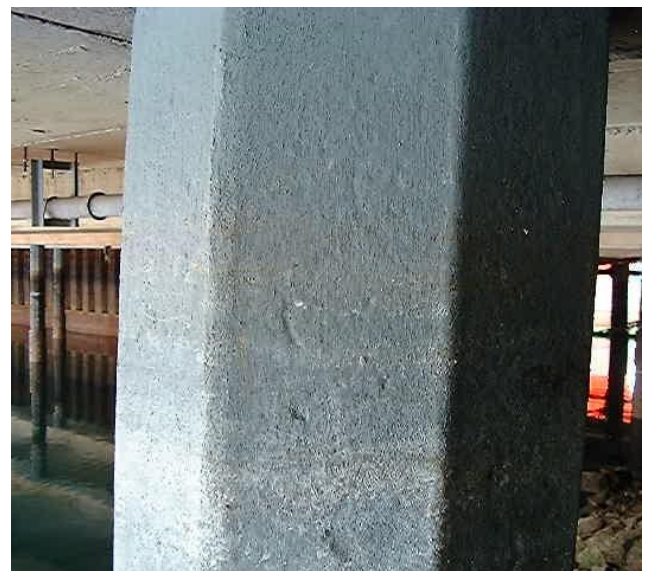
These pictures of the pier legs were taken in August 2001: one year after the application. The **ZINGA** is holding perfectly with no rust showing. Any marking on the legs is either seaweed or harbour contaminants.

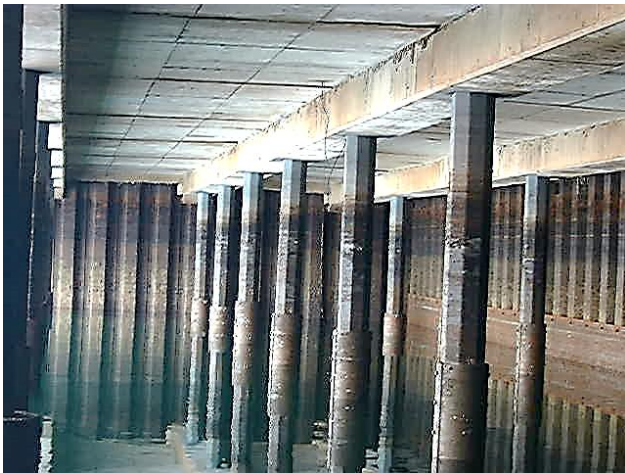
These pier legs have been in the sea for 25 years and due to the salt and the sulphate reducing bacteria present in the seawater, they were losing up to 2 mm per year of their thickness. The waters around Killybegs are unique because they have the highest rate of corrosion in Europe.

The height from the concrete deck to the water level at low tide is approx. 3 to 4 meter. At high tide, 1.5 to 2 meter of each pile is totally submersed in seawater.

The piles were prepared by UHP water-jetting and blasting to SA 2.5 with Rz 40 to 60 μm . The application happened under severe surveillance of SGS, because it was a very difficult and delicate application as they had to take into account the tidal movement of the water and the constant contact with sea water. SGS had prescribed a dry film thickness of ZINGA of $25 + 40 + 40 + 40 \mu\text{m} = 145 \mu\text{m}$, but in the end an average of $300 \mu\text{m}$ was measured.

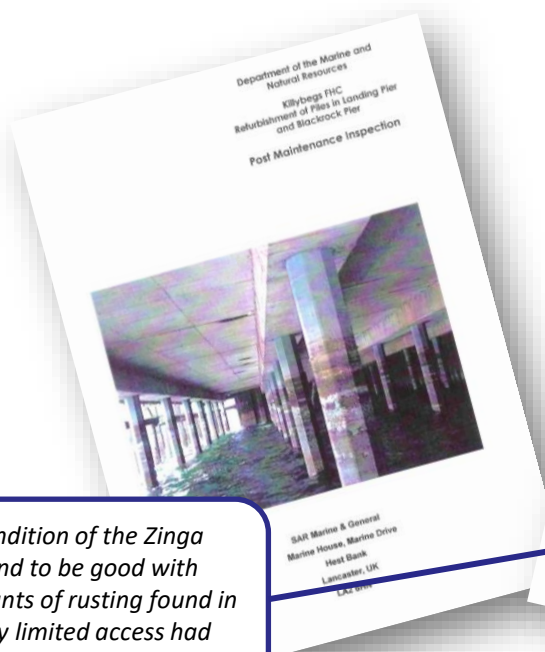
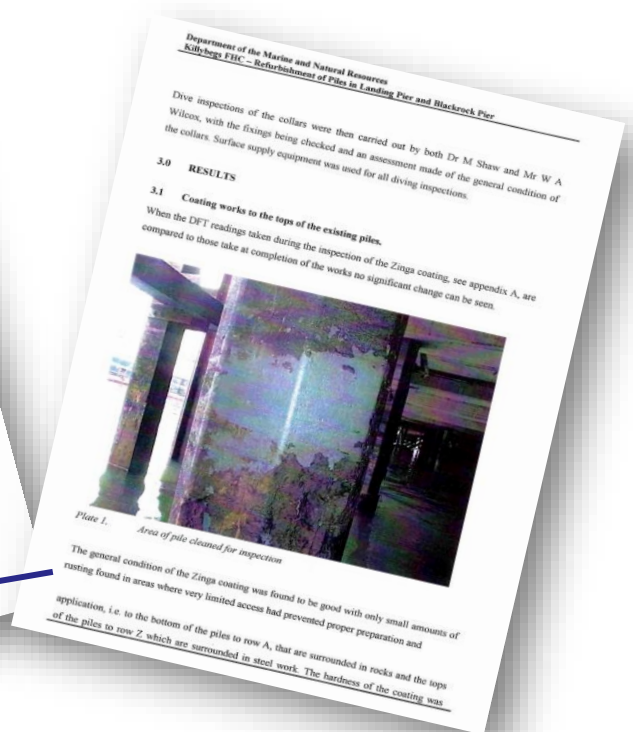
"The general condition of the Zinga coating was found to be good with only small amounts of rusting found in areas where very limited access had prevented proper preparation"

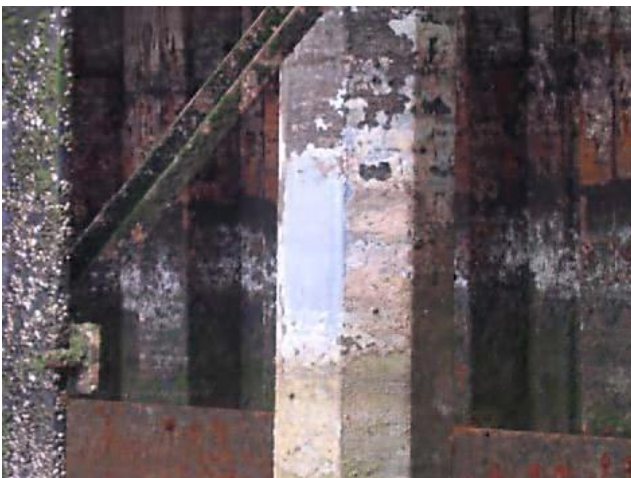
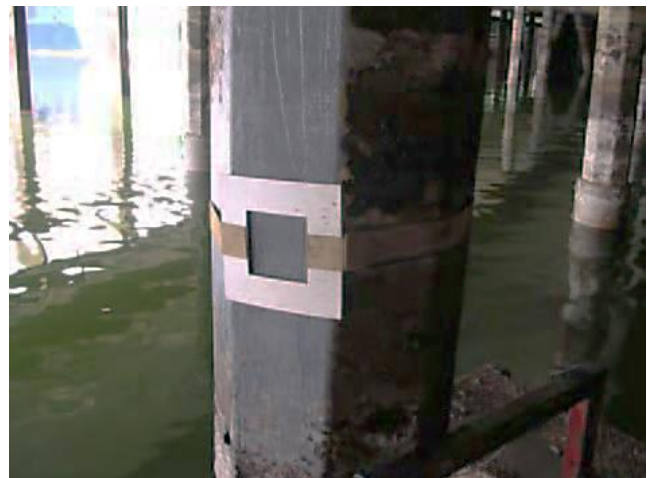
Brief conclusion	See paragraph
Some minor repair work has to be done on piles with areas difficult to reach. The cleaning of the reference piles with HP (warm) water didn't give any problem. The all-over dry film thickness hasn't change significantly.

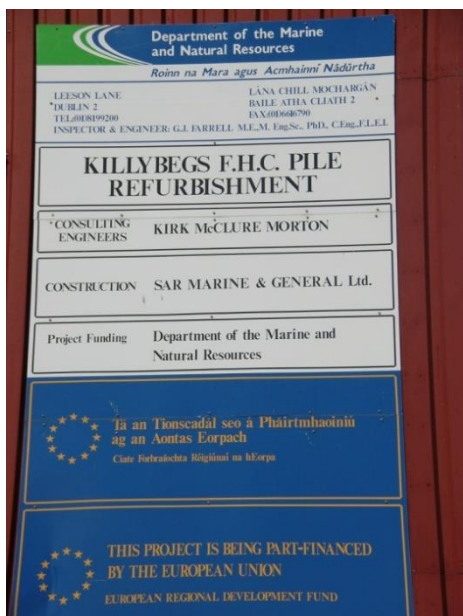
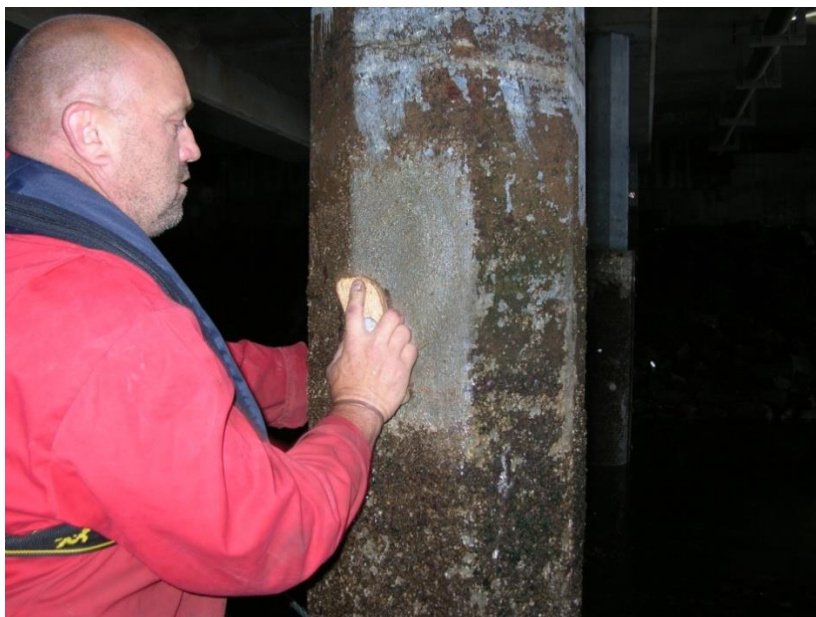
Brief conclusion	See paragraph
<p>The piles do not show any significant changes although the repair works after 3 years have just started recently.</p> <p>Only on some piles we find some corrosion on the upper 0,5 till 1 m. Touch-up is going on. The cleaning of the piles with nylon brushes and water doesn't cause any problem.</p> <p>The all-over dry film thickness has increased with another 11%.</p>

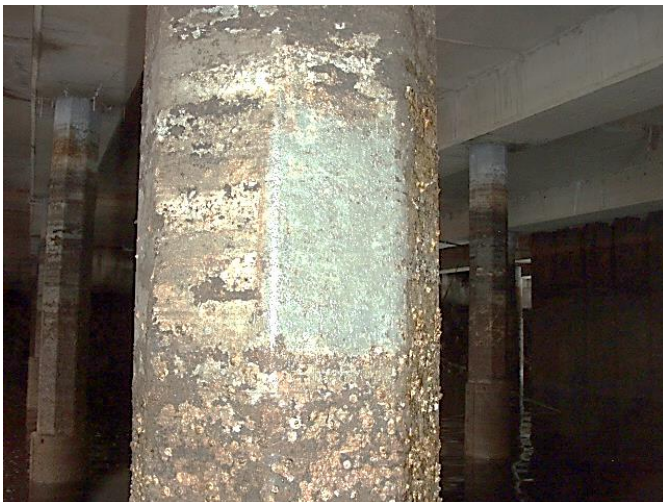
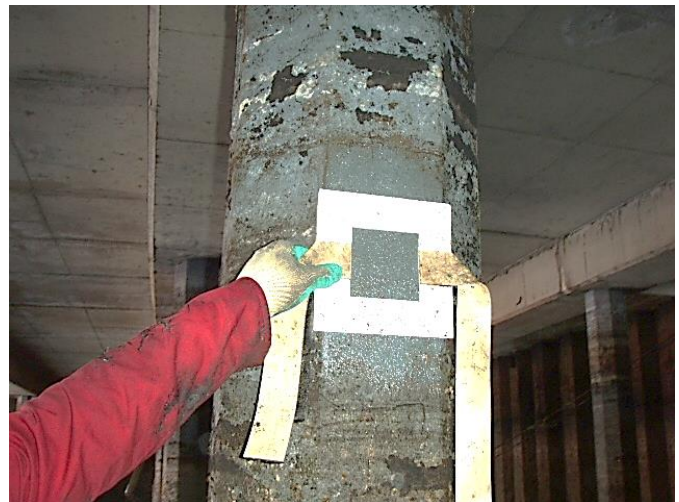
The piles didn't show any significant progress in corrosion since the last inspection in 2006 (after 6 years in service). Only on the piles at the Blackrock Pier we saw slight corrosion on the upper 0.5 to 1 m. The touch-up done before and during the last inspection in 2006 shows some blistering. This is probably caused by remaining salts underneath. The overall thickness has not significantly changed.

The coating is at present in quite good condition; if well maintained, the system can remain in service for another 10 years.

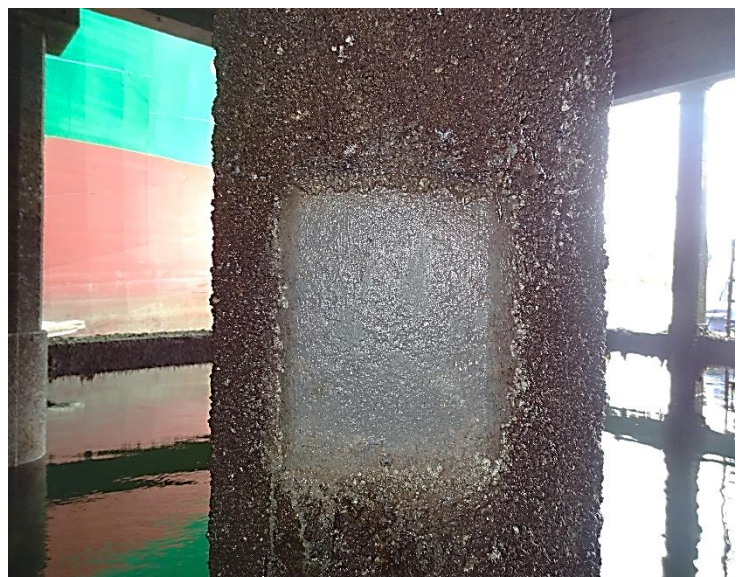
The shells & barnacles on the surface of the **ZINGA** layer had grown more than 100 mm in thickness on some places, **but the ZINGA underneath was still in perfect condition.**
