CULVERTS – WALES – UNITED KINGDOM

Some views of sub culverts beneath a new bypass to alleviate severe flooding conditions in Bangor-On-Dee, Wales.

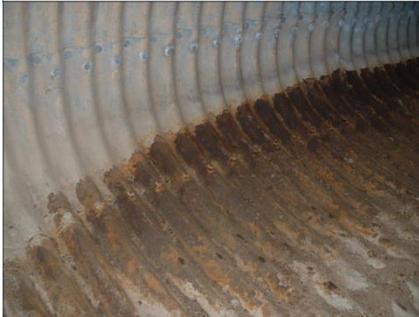
Culverts rusted from nitrates in the field water.

Problem: Heavily nitrated water from adjacent farm fields was lying with the corrugations of the sub-culverts and was oxidizing the HDG at an accelerated rate. These culverts were heavily pitted and were in danger of perforation.

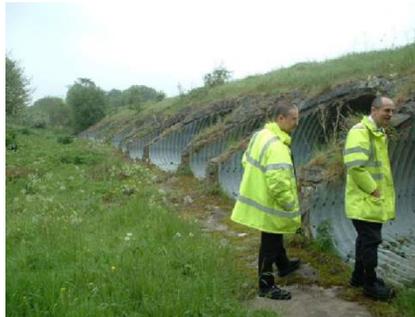
County Council engineers doing an inspection.

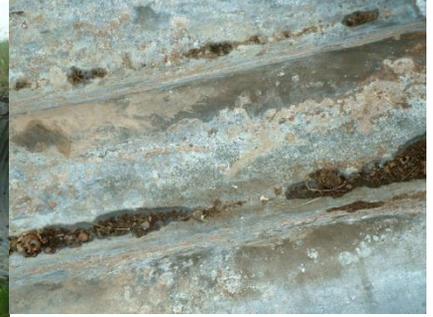
The pitting in the HDG was very deep.

- Brushing out soil before blasting
- Hydro-blast: to remove all mud and salts

Application of **ZINGA** to 140 µm DFT

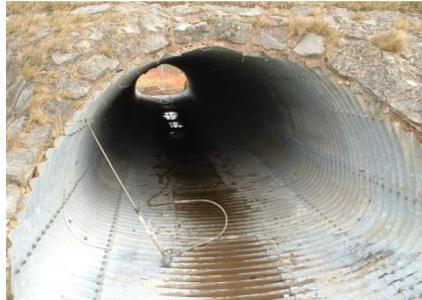
Brushing out the sand and soil before blasting.

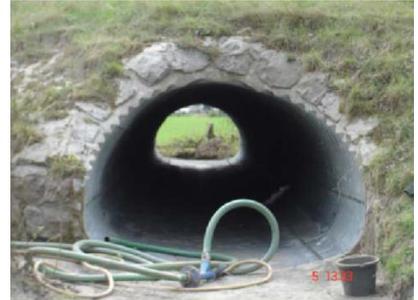
Ready for blasting and coating the culvert steel.

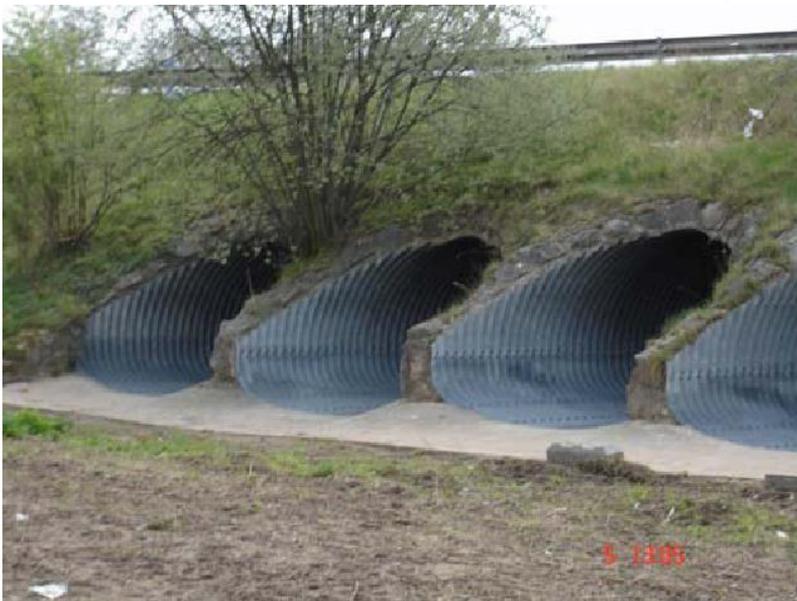
After ZINGA application

Application was finished in January 2008

System:
Zinga : 2 x 70 µm DFT
