PAPER MANUFACTURING PLANT – PAPIRUS – BRAZIL

In December 2010, a test application was performed at the paper producing plant – a hot and humid indoor facility.

A test area was decided, and two systems were compared:
A **ZINGA** duplex system (**ZINGA** + epoxy)
and a conventional epoxy system
(2 layers epoxy).

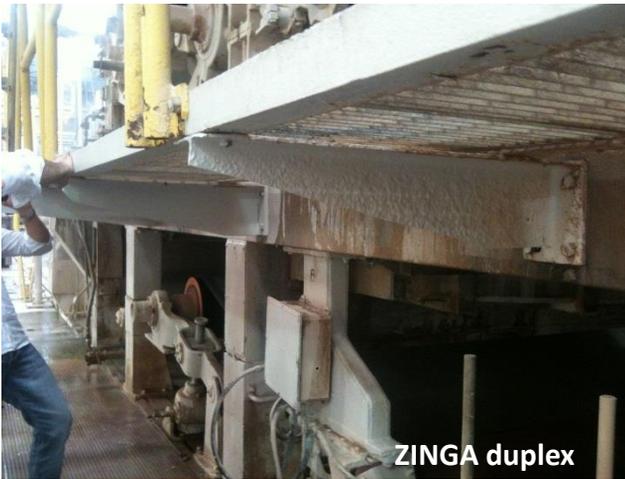
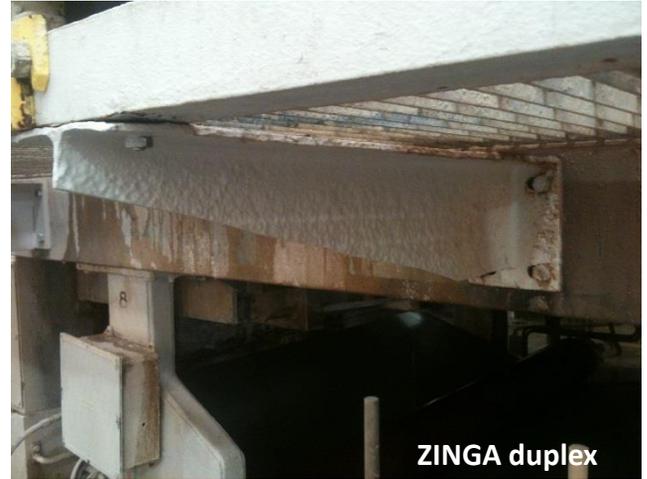
24 months after ZINGA application

After 24 months, the ZINGA system showed no signs of corrosion. All supports not treated with ZINGA received the ZINGA system after 18 months

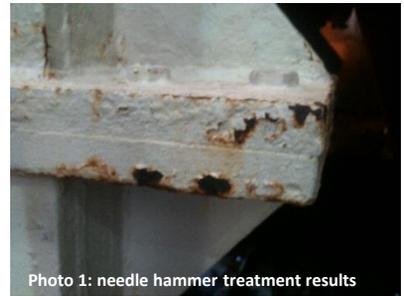
- Maintenance team concluded that the desirable surface treatment is SA2½ and roughness profile above 40 µm obtained with steel grit blasting in the shop, as best results of system performance were obtained.
- Surface treatment with needle hammer produced insufficient standard resulting in eventual coating failure (photo 1 right).
- Surface treatment with steel brush mechanical tools reached ST3 standard resulting in better (not best) coating protection with very few coating failure points, an acceptable situation as it multiplied the times between maintenances (photo 2 right).

Photo 1: needle hammer treatment results

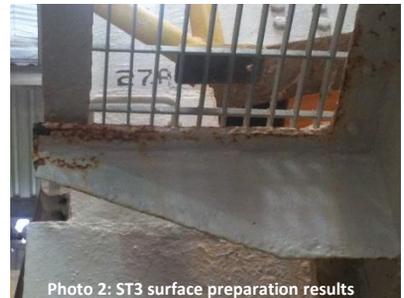
Photo 2: ST3 surface preparation results
