CIMENTERIE SCHWENK – BERNBURG – ALLEMAGNE

En 1992 la nouvelle usine de Bernburg des cimenteries **SCHWENK** a été protégée au **ZINGA**.

Cement factory SCHWENK at Bernburg /East Germany / Inspections on ZINGA after over 10-years after application and submission under rough production conditions.

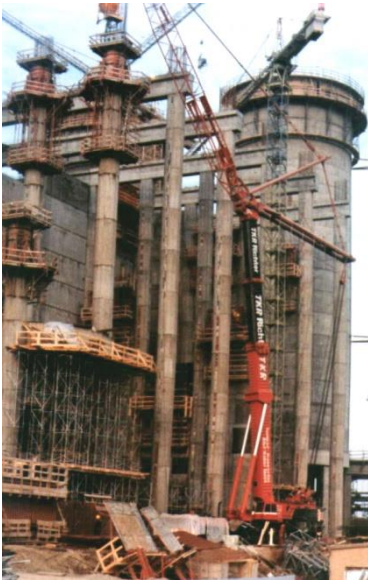
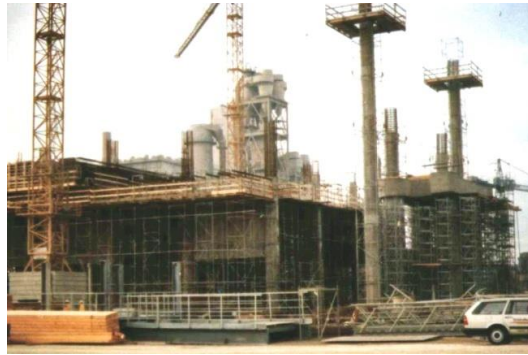
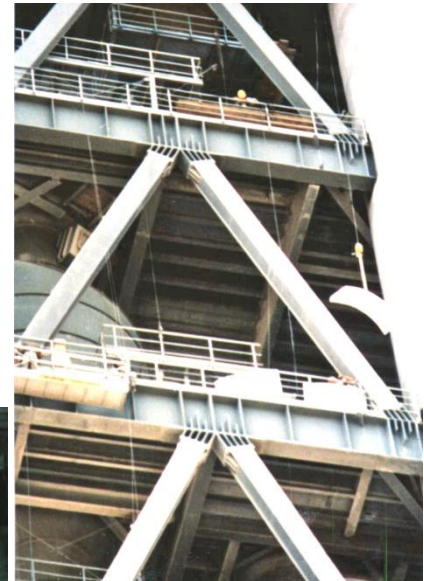
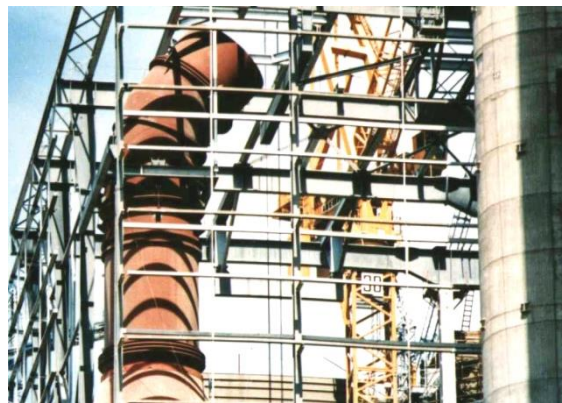
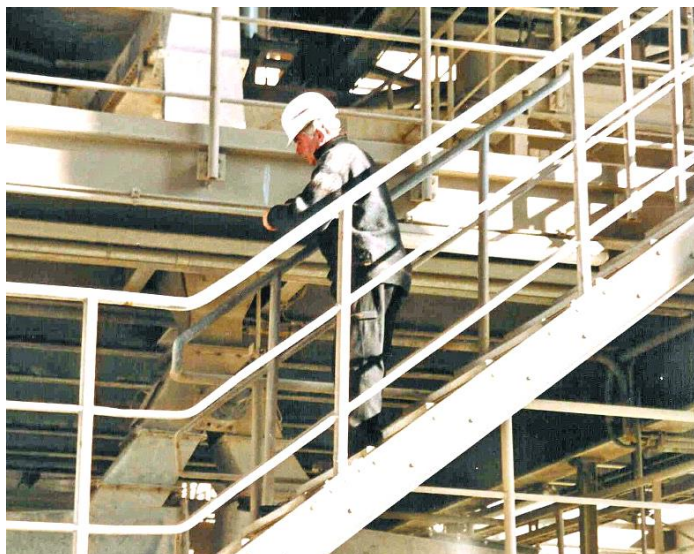
Ces photos ont été prises pendant la construction.

En Février 2003, l'état de la couche de **ZINGA** a été inspecté. Les photos vous montrent que le **ZINGA** est encore en parfait état. Il n'y a pas de traces de rouille après plus de 10 ans.

Sur la face de l'usine exposée aux intempéries, où des produits abrasifs et la pluie attaquent et nettoient la surface, l'épaisseur de la couche de **ZINGA** avait diminué de 120 μm à 70 μm . Ceci représente 5 μm de perte par an, ce qui est raisonnable en considération des conditions environnementales très sévères.

De l'autre côté de l'usine, moins exposée, où il y avait cependant une grosse couche de poussière qui adhérait au **ZINGA**, l'épaisseur de la couche n'avait diminué que de 120 μm à 115 μm . Soit à peine 0,5 μm par an par rapport à l'autre côté avec une perte de 5 μm par an !

Sur cette photo la poussière est enlevée et la couche complète de **ZINGA** devient visible.

Plus tard, le **ZINGA** sera rechargé facilement en appliquant une nouvelle couche sur une surface nettoyée !
