TANKS – NEW PLYMOUTH – NEW ZEALAND

In 2007, two tanks of the **New Plymouth Power station** in New Zealand were protected with **ZINGA**.

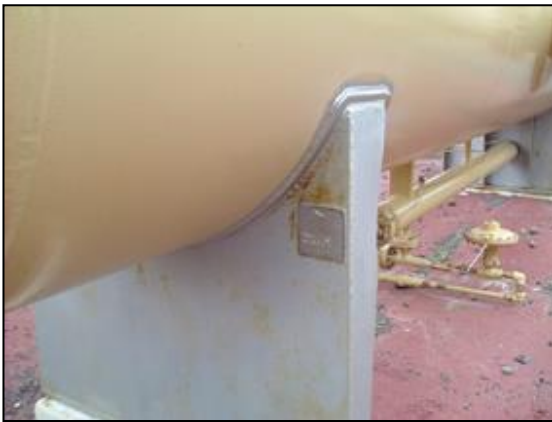
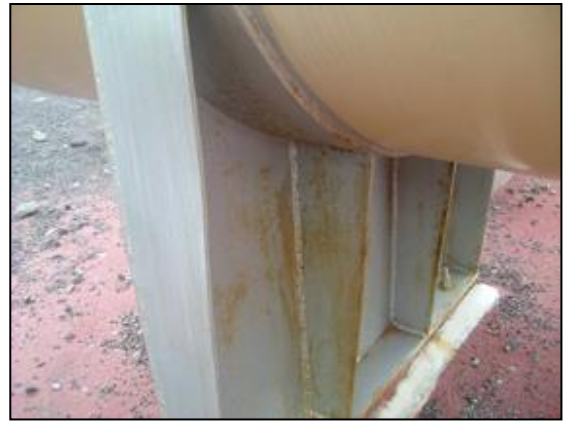
These tanks have to endure the sea mist of the New Plymouth coast, which is the cause of the high corrosion rate and the appearance of red rust on the old system.

Before application with **ZINGA**: visible rust spots.

System:
decontamination by UHP cleaning
blasting to SA 2,5.
Zinga 2 x 90 µm DFT

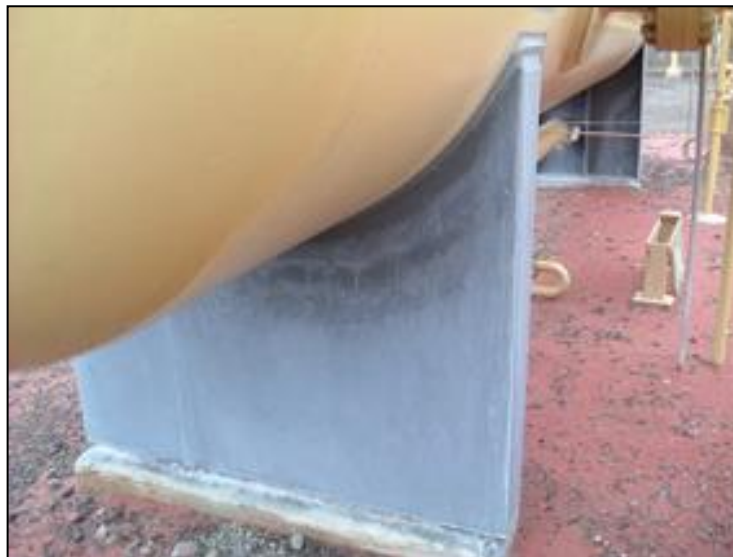
About one month after application with **ZINGA**.
