## HUSEVAGOY FERRY TERMINAL – NORWAY

Application of **ZINGA** in Maloy, North West Coast of Norway in 2012 & 2013 for protecting the pipes of the Ferry Terminal. Works were executed by **Mestas AS** for the Owner **Norwegian Public Roads Administration, Road Authorities**. Due to a high level of salts **ZINGA Norway** stopped the project in 2012 but the owner still asked to get the 2 inner pipes coated even with the high level of salt contamination of 60 mg/sqm. It became a test project with the high salt levels.

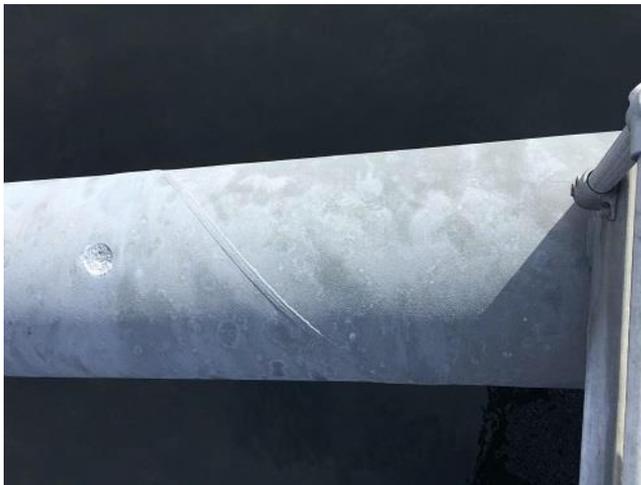
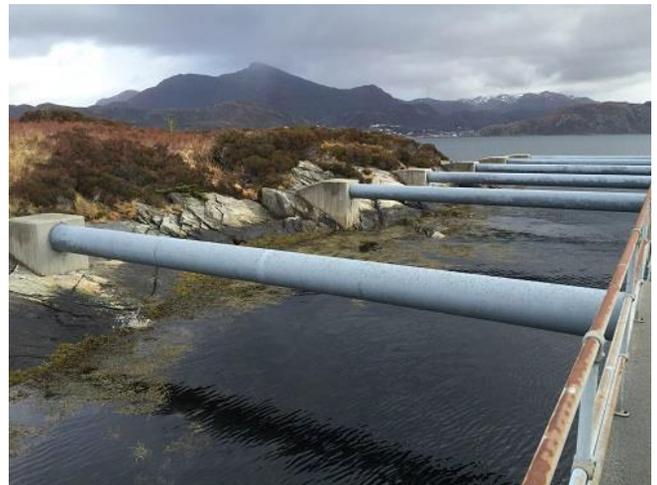
An inspection in the Summer of 2016 (after 3 and 4 years) carried out by the Public Road Administration (SVV) and a representative of ZINGA AS revealed no problems.

System:  
ZINGA      2 x 90 µm DFT

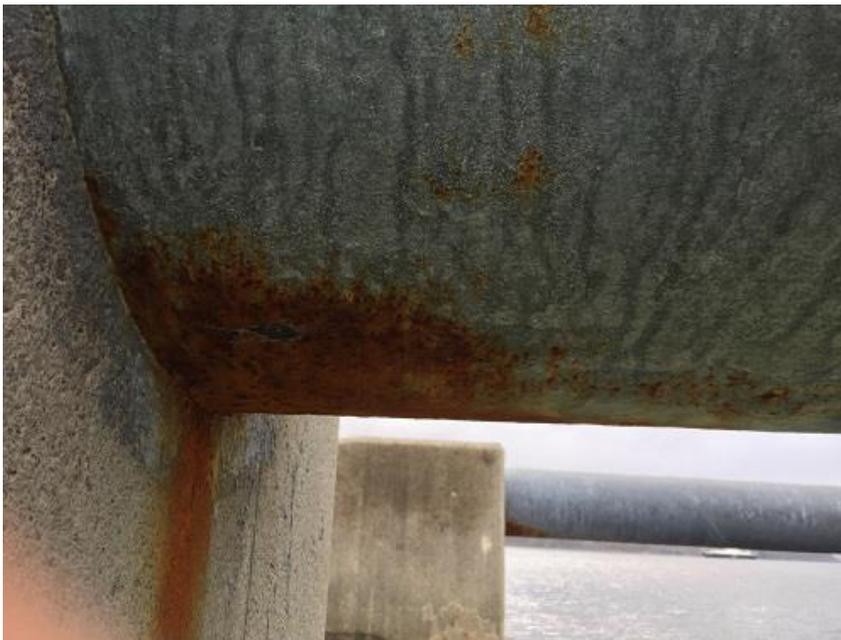
After 3 years

An inspection in the Summer of 2019, **resp. 6 and 7 years after ZINGA application**, carried out by the same **Public Road Administration** showed still a good performance of the **ZINGA** protection with 180 µm.

Some smaller areas showed tendency to failures (rust) which were due to differences in preparation/application. Those areas can be repaired easily by cleaning the surface, roughing up the area with steel brush and apply a new **ZINGA** layer with a brush.

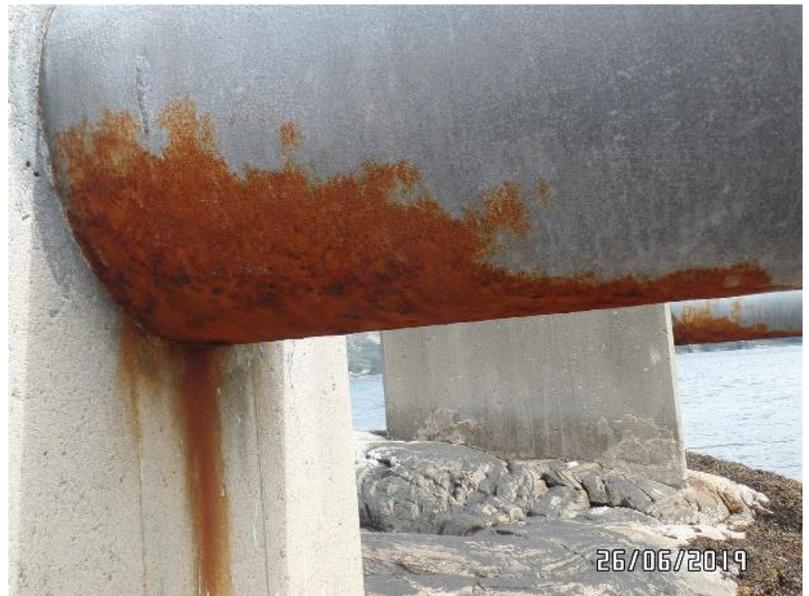
After 6 years

This project shows clearly that when preparation and /or application is not done up to the best standard on the whole structure and under such harsh conditions, failures can occur.
