## Grain Silos & Flour Mills – AL ARABIYA – YEMEN

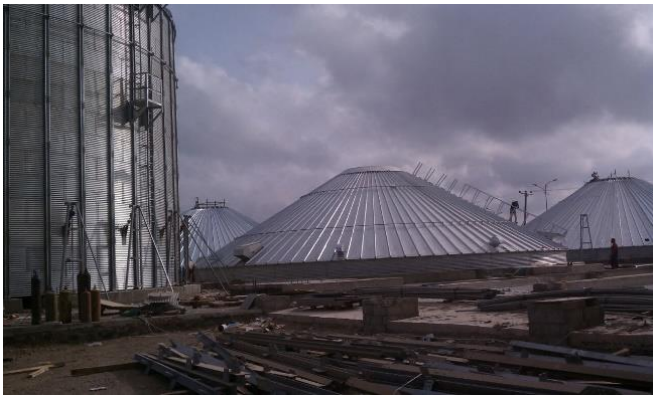
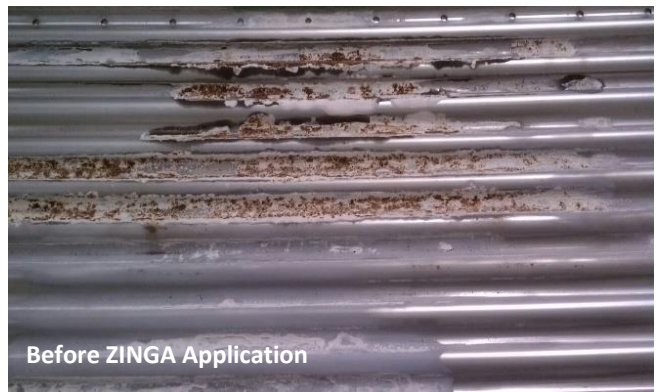
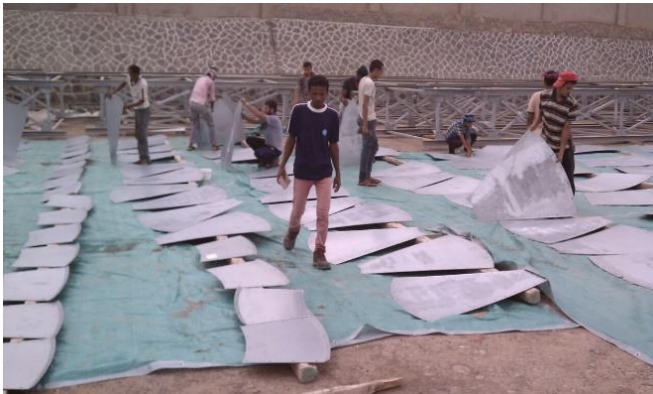
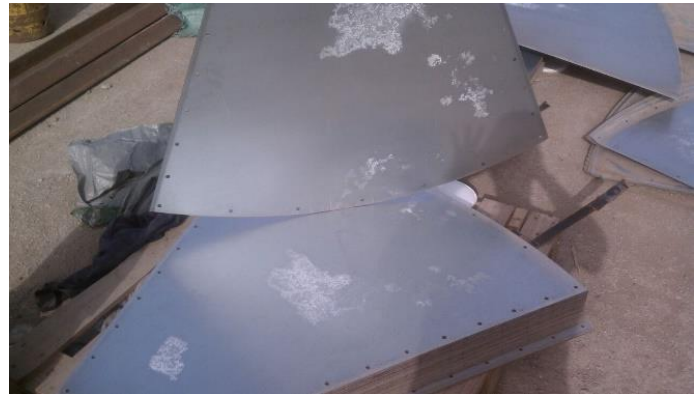
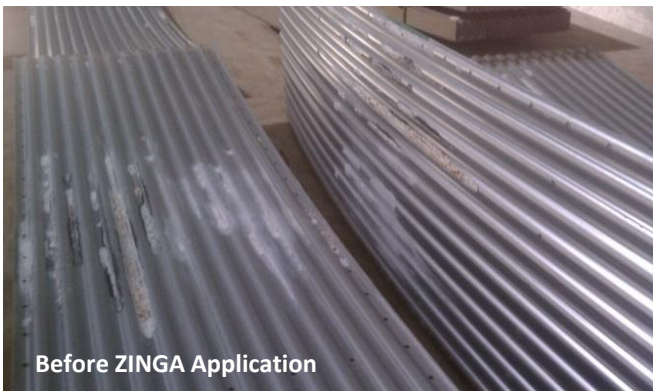
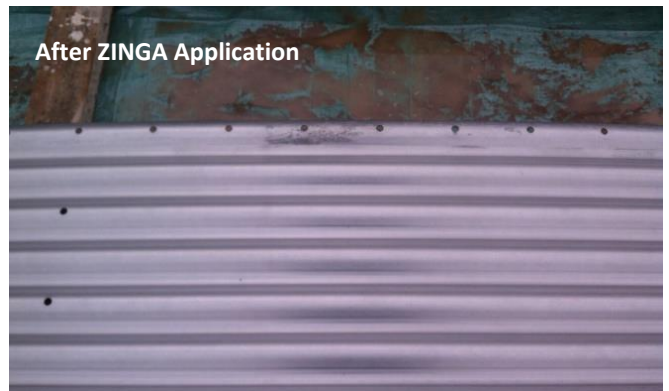
In 2015 the **Al-Arabiya Grain Silos** company requested the use of **ZINGA** as touch up of galvanized steel for their new project in **Hodeidah Port**, Republic of Yemen. They left the structures for 2 years in bad storage conditions causing white and red rust. The repair process was successful, and they used 1.5 tons of **ZINGA**. The surface was prepared using manual tools along using some chemical products for white rust removal and washing by fresh water. The **ZINGA** was applied by brushes and all patch repair work was done before erection.

System:

ZINGA

2 x 60 µm DFT

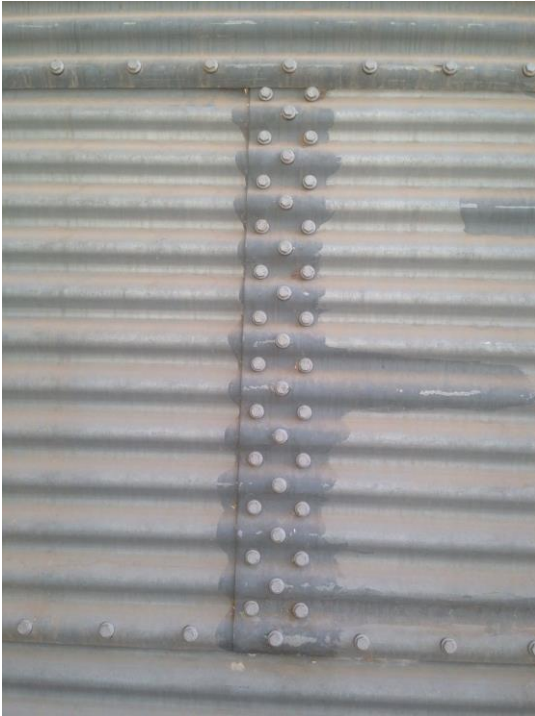
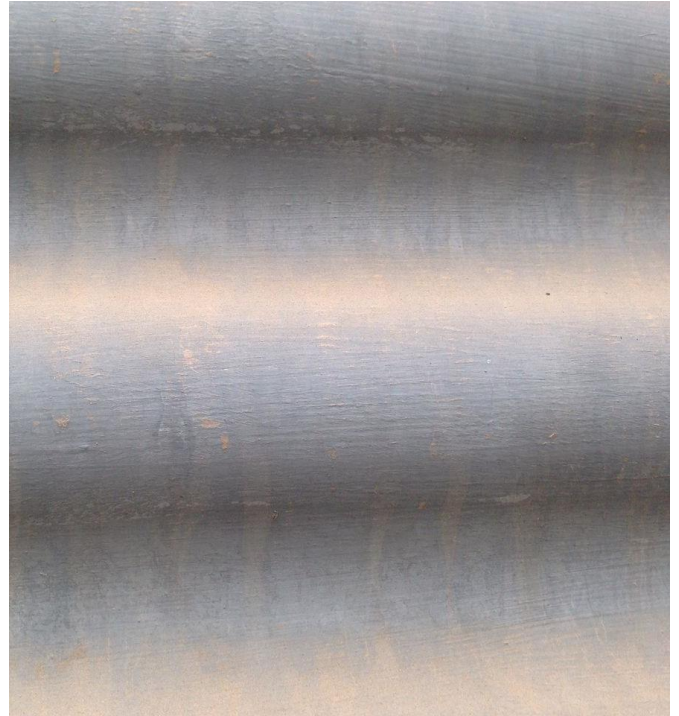
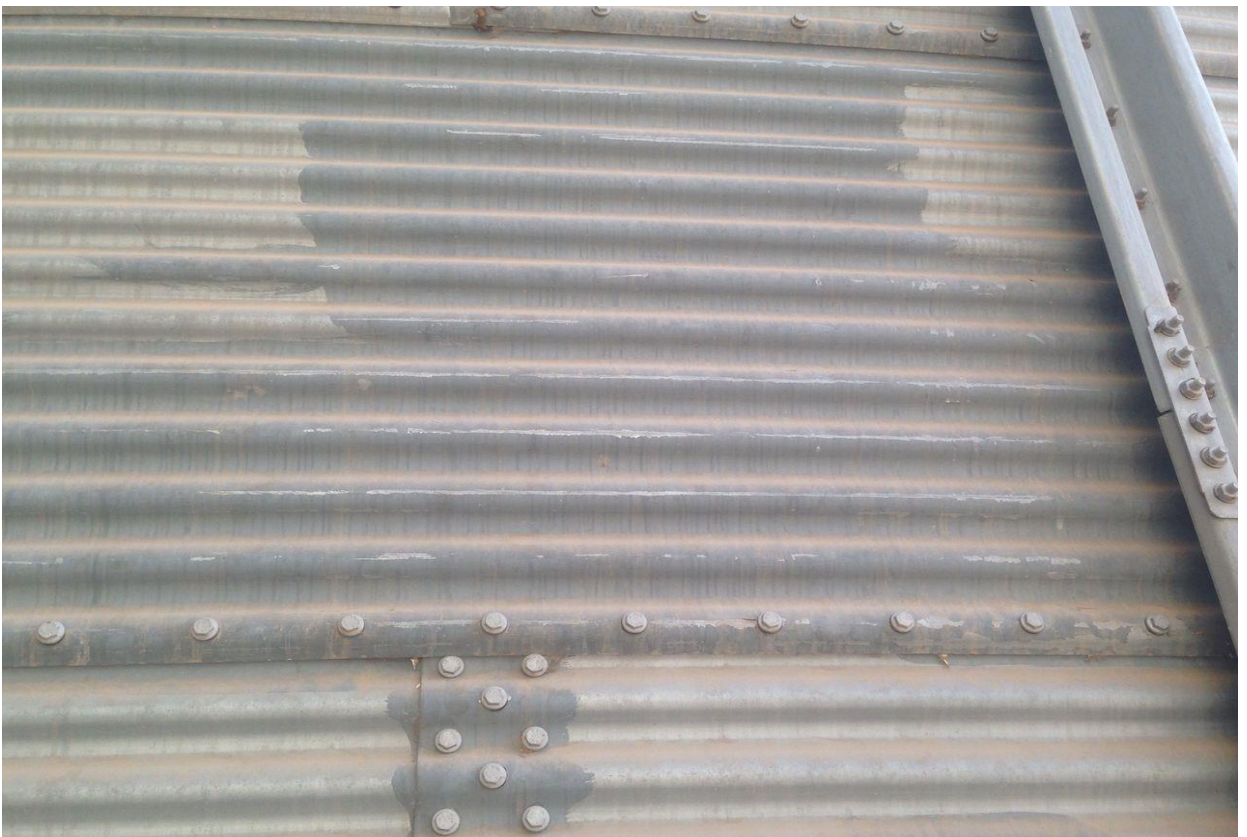
2 years after application the ZINGA was covered under sand and the only visible damages were the result from manipulation and assembly.
