## WATER TANKS – S/Y ADELA – UNITED KINGDOM

Water-tanks coated with ZINGA in 1998 and again in 2006.

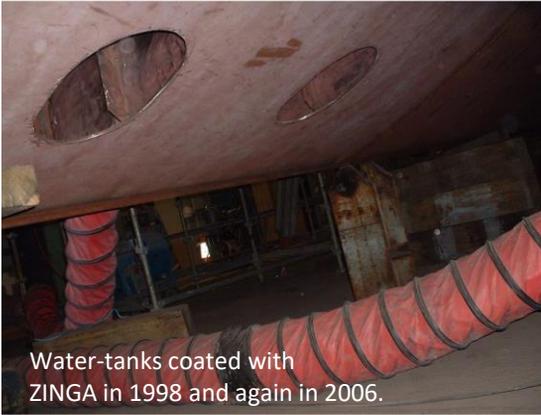
In 2006, **8 years later**, an inspection was done on the water tanks. The Captain had a quick look into the tank and saw that all the zinc had been used up, hence the tanks were covered with rust. But a further thorough inspection revealed that the rust was in fact coming from a few uncoated areas and was spread evenly over the Zinganised surface due to the swaying of the hull.

Underneath the rust there was still a beautiful layer of **ZINGA**.

It was decided to cut six access hatches below the waterline to allow proper access for a person and blast-hoses into the tank areas. This was subsequently done to a Lloyds specification with the six hatches being a flush fit below the waterline. The **ZINGA** application on this project was done by UNIPREP.
