## STORAGE TANK - STROM- UND HAFENBAU HAMBURG PORT AUTHORITY – GERMANY

In 1989 an oil storage tank was protected with **ZINGA** by the engineering office of **Strom- und Hafenbau Hamburg**, the Port Authority.

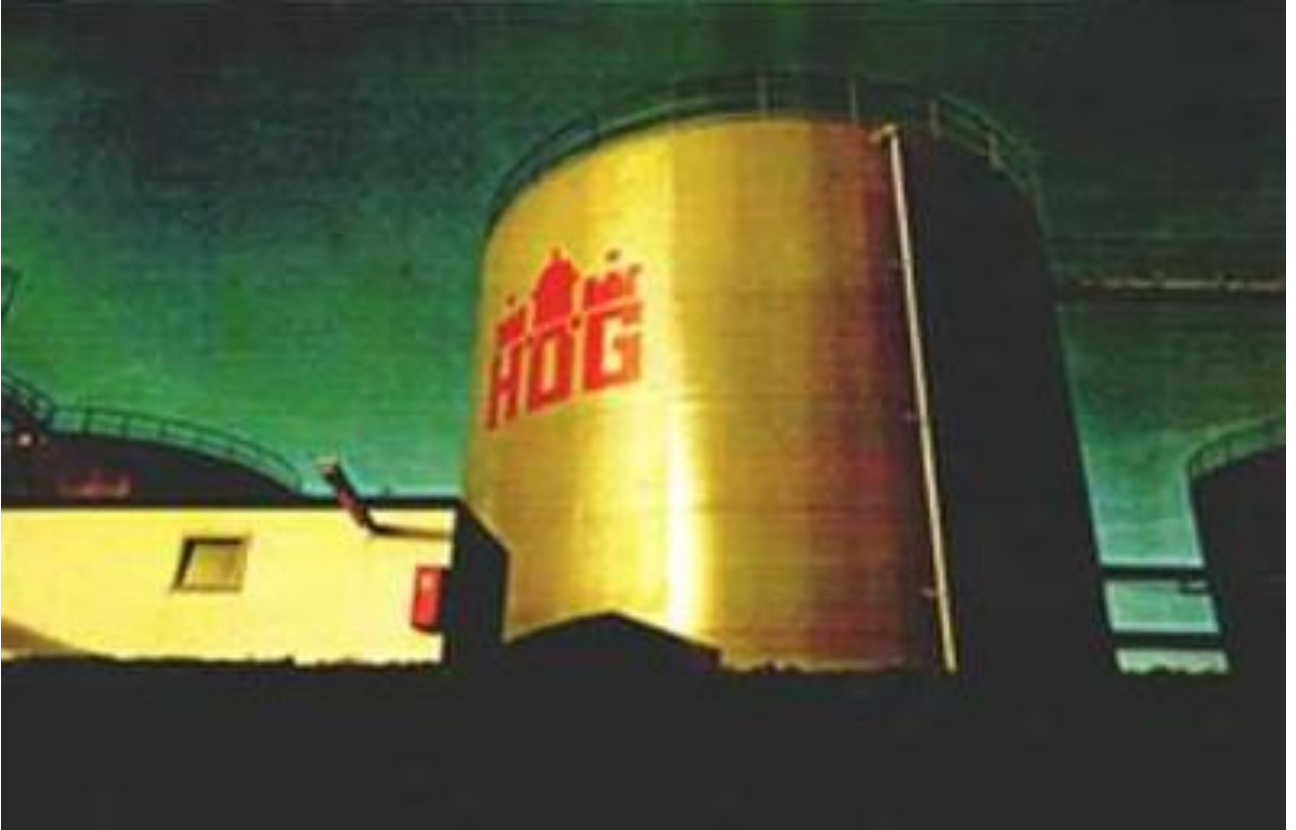
The tank was evaluated after 10 years.  
The coating system was still in a perfect condition.  
You will find a testimonial letter from **Strom- und Hafenbau** on the next page.
