PAPER MANUFACTURING PLANT – PAPIRUS – BRAZIL

In December 2010, a test application was performed at the paper producing plant – a hot and humid indoor facility.

A test area was decided, and two systems were compared:
A **ZINGA** duplex system (**ZINGA** + epoxy)
and a conventional epoxy system
(2 layers epoxy).

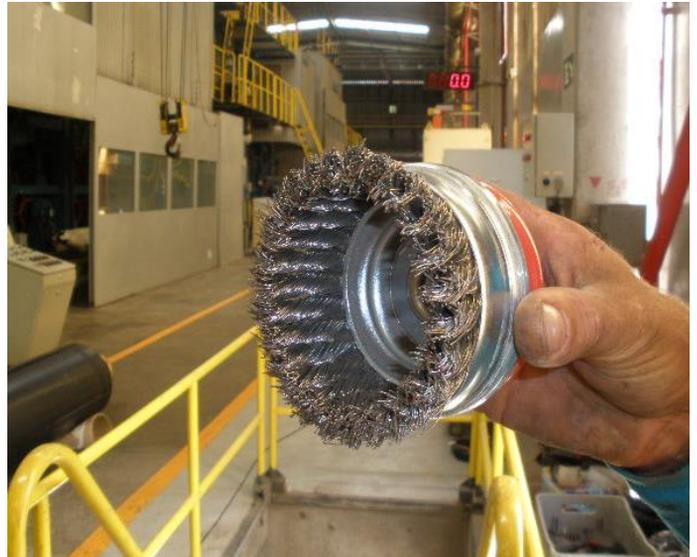
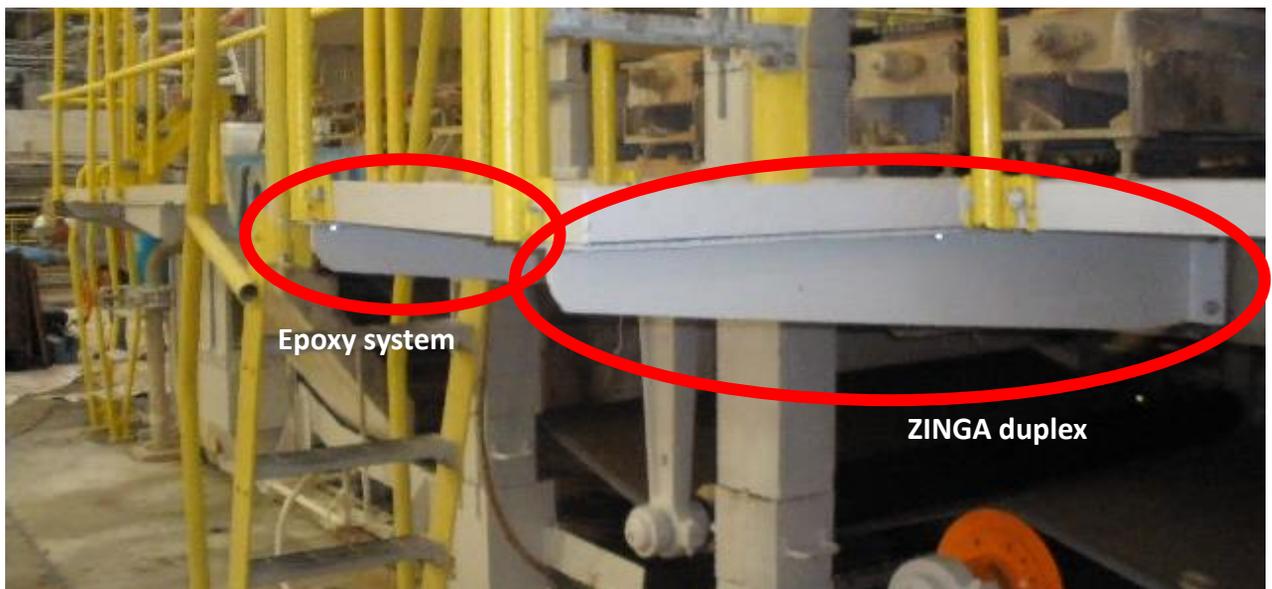
The application conditions were not ideal: the surface could not be optimally prepared, and hand tools were used (steel brush), obtaining ST3 cleanliness.

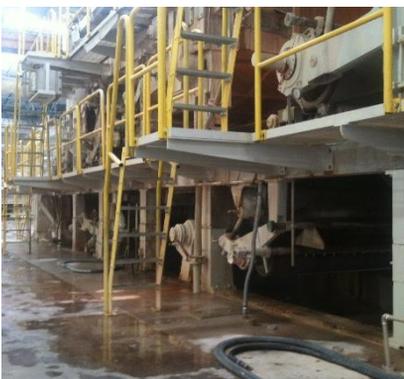
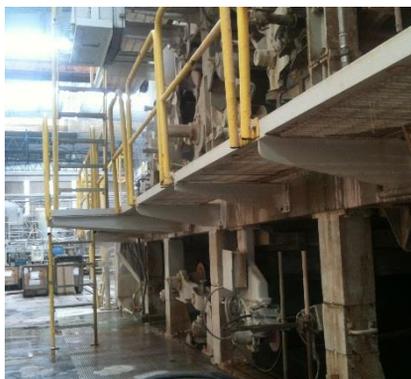
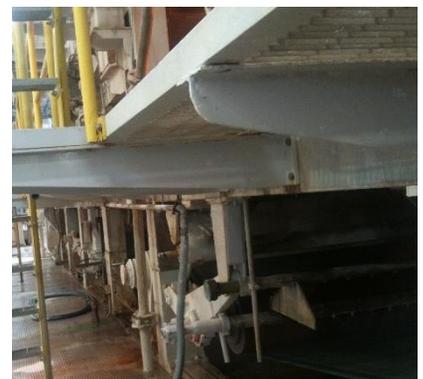
Below: Overall view of the wet end of the paper machine (control side): maintenance and production management adopted ZINGA as standard coating for the paper machine.

In 2015, **5 years after the test application**, maintenance kept concluding that **ZINGA** multiplied by 5 the time in between maintenances, even with the less than recommended surface preparation.
