MINE DE CHARBON - EXXARO KUMBA GROOTGELUK AFRIQUE DU SUD

En 2005, KUMBA RESOURCES (devenue **EXXARO**) a commencé avec l'application de **ZINGA** sur leurs infrastructures (6 500 m² au total). À l'origine, ils appliquaient une seule couche mince de **ZINGA** (parce qu'ils avaient utilisé trop de solvants), ce qui n'était pas suffisant.

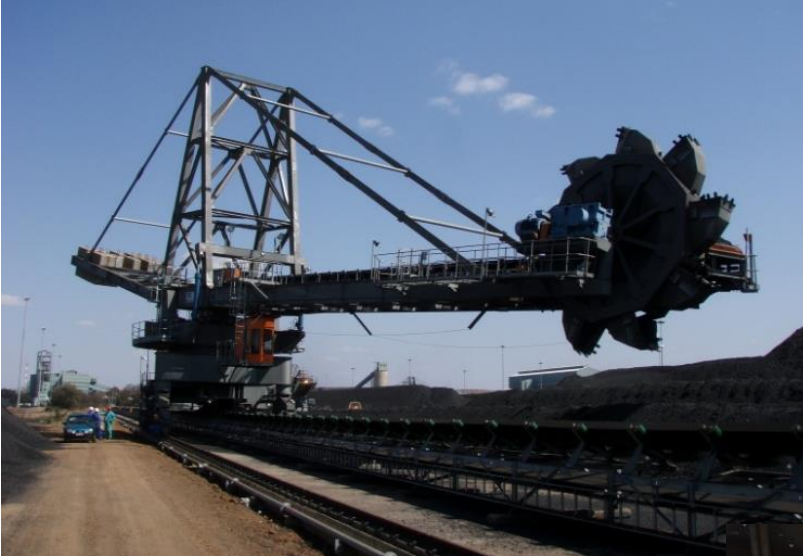
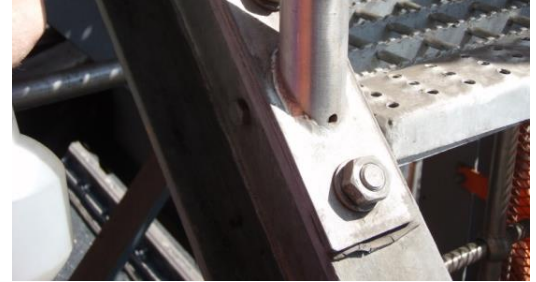
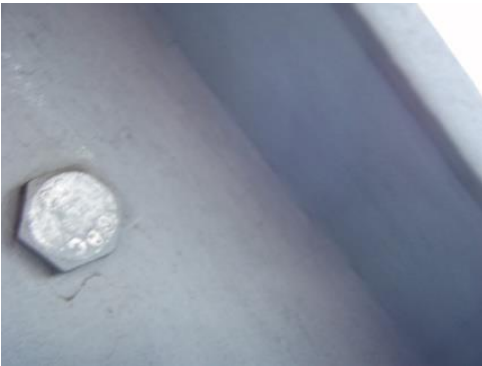
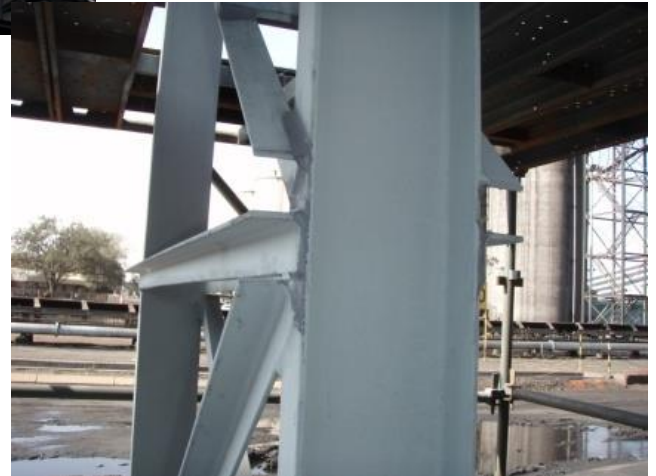
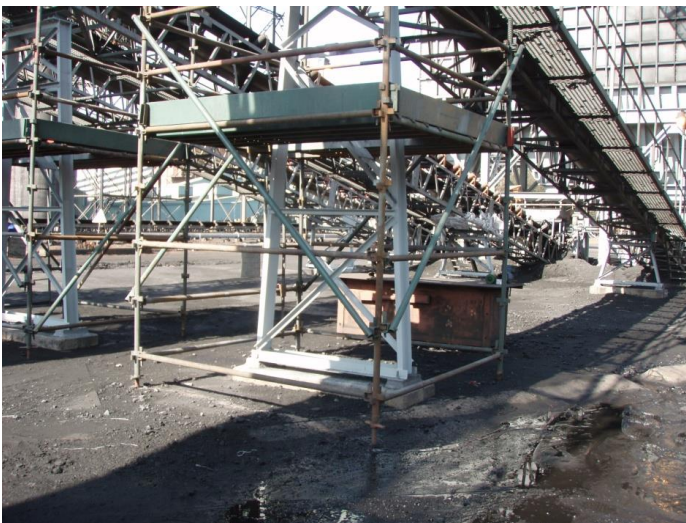
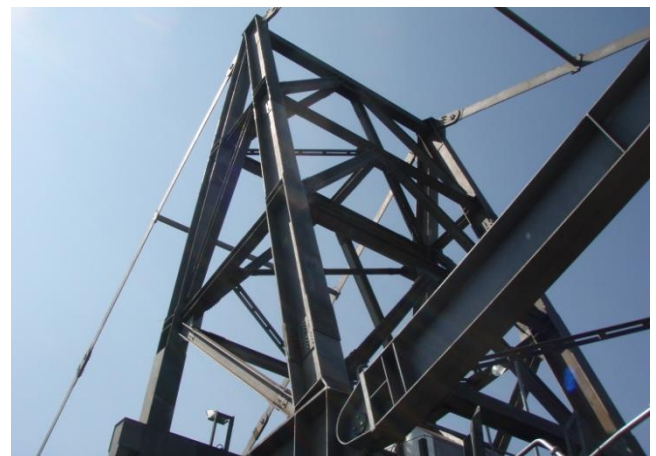
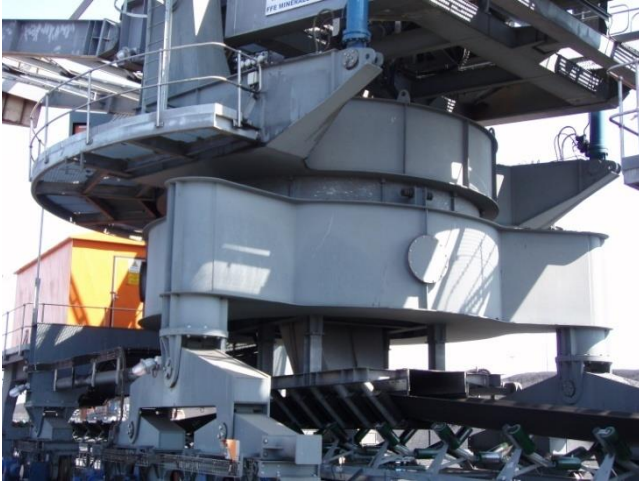
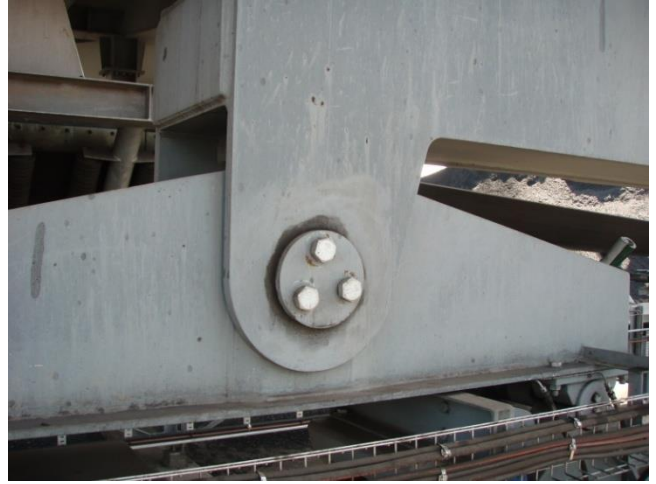
Système:

ZINGA

120 µm EFS

Le client a effectué une inspection indépendante sur la condition du **ZINGA** en Octobre 2006 et à nouveau en Février 2007.

- 1 As per the photographic report I conclude that Zinga has achieved galvanic protection and that no deterioration of the coating was witnessed.
- 2 Structural steel installed in Plant above screens exposed to continuous moisture and water has shown no reduction on dry film thicknesses.
- 3 Column bases done with Zinga metall exposed to water, coal fines and occasional impact has shown no reduction in dry film thicknesses.
- 4 No cracking of the sealing compound from the steel column to cement base was witnessed.
- 5 Zinga must be applied in accordance with MPC5 04 and it's the responsibility of the applicator to ensure that required DFT'S are obtained.
