TRANSMISSION TOWERS of SANTA RITA BALFOUR BEATTY POWER PLANT - PHILIPPINES

In 1999 ZINGA was used to repair old hot-dipped structures at the **Santa Rita 1000MW power plant** and OHTL (OverHead Transmission Line) ranging from Santa Rita to Calaca (existing coal-fired power plant).

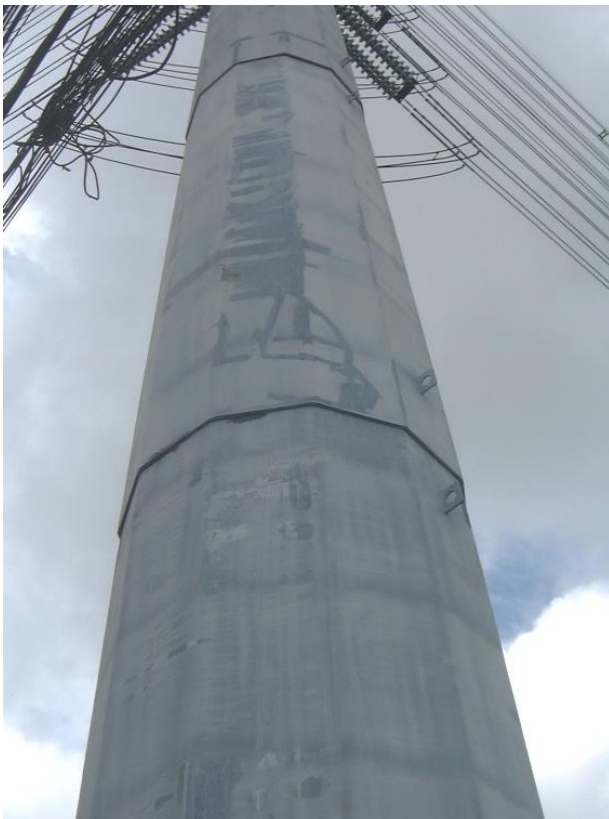
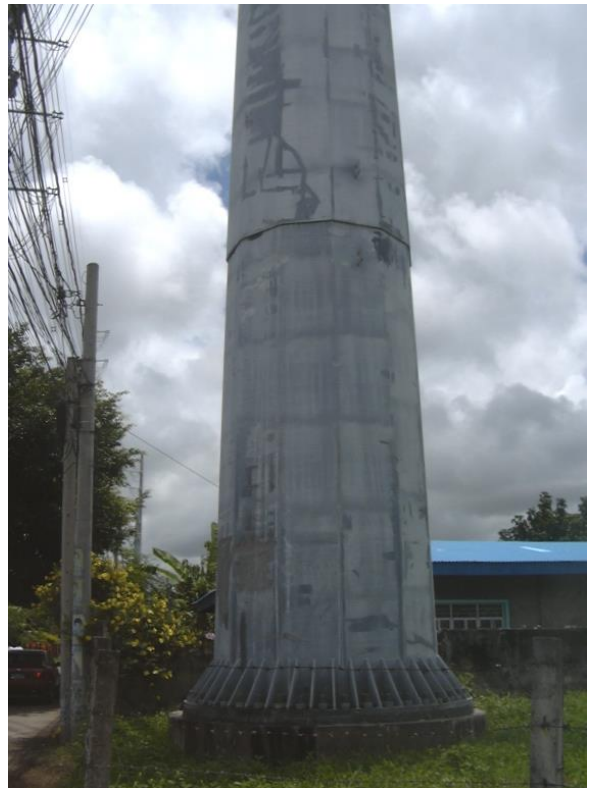
These pictures were taken in 2003,
4 years after the application of ZINGA on old,
damaged hot-dip and no rust was detected at all.

System:
Surface preparation:
Thorough decontamination of
old hot-dipped surfaces
ZINGA 1 x 60µm DFT
