SLUICE GATE – SUBIC WATER – PHILIPPINES

In April 2009, 2 layers of **ZINGA** were applied on a new sluice gate in **Subic Bay Freeport Zone**. The constructor 'Macro Machinery' used **ZINGA** to protect the sluice gate they delivered to '**Subic Water & Sewerage Company**'.

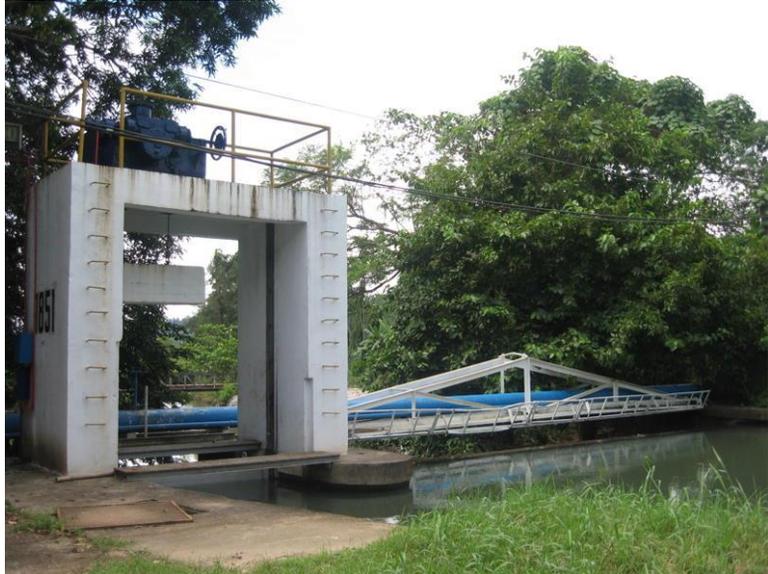
This new sluice serves now as a replacement for the old gate which was corroded severely after having been treated with epoxy paint.

About 25 Kg of **ZINGA** was used on the 22m² structure.

System:
Surface preparation:
Grit blasting to SA 2,5
(near white metal)
ZINGA 2 x 60 µm DFT
(spray application)

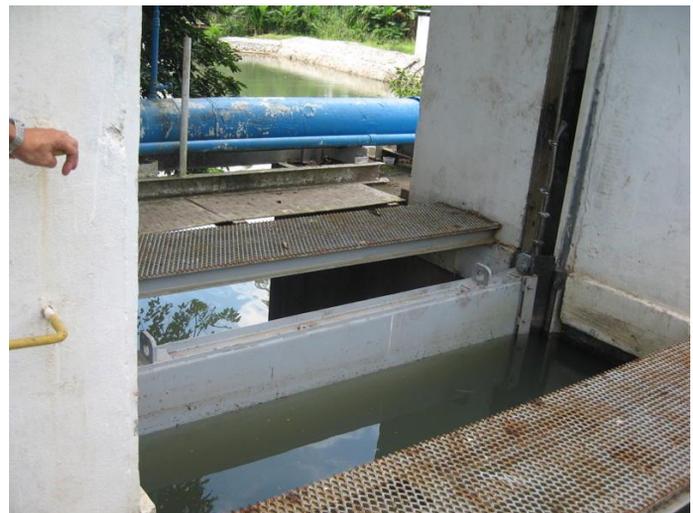
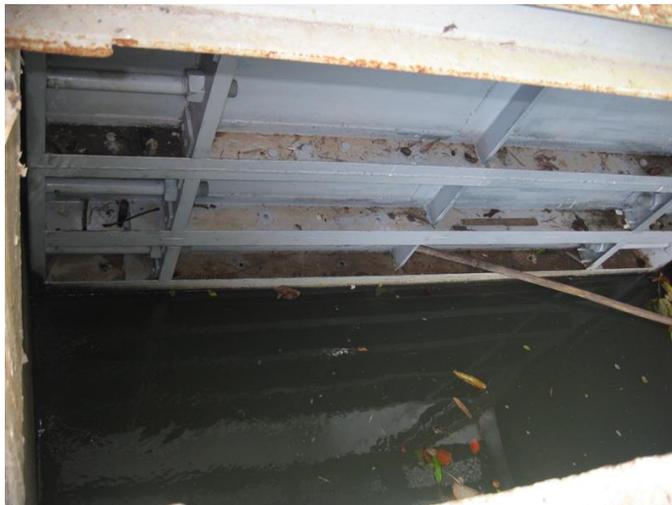
In September 2011, the gate was inspected and no noticeable problems were noted. Only 1 minor touch-up was required where a weld wasn't sufficiently repaired.
