Coastguard vessel – Incheon – South-Korea

A trial application was done with **ZINGA** on a coastguard vessel in South-Korea. The existing coating was entirely removed and the surface was treated with a salt remover. **ZINGA** has been applied as a primer and topcoated with Vinyl Paint FS-26081. This topcoat is regularly supplied to the **South-Korean coastguard**.

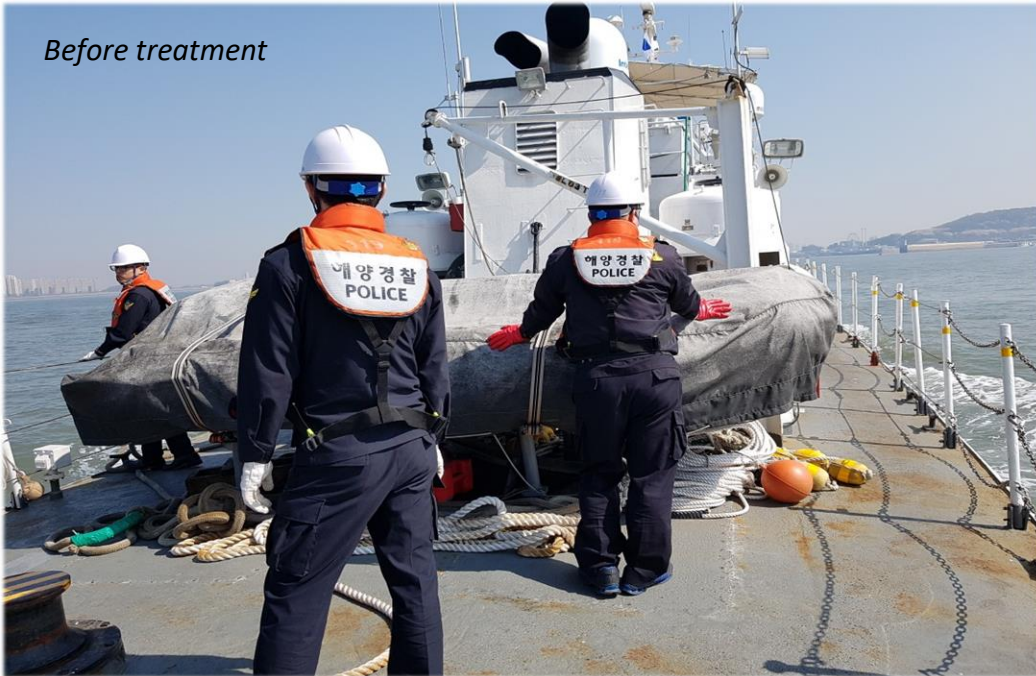
Before treatment

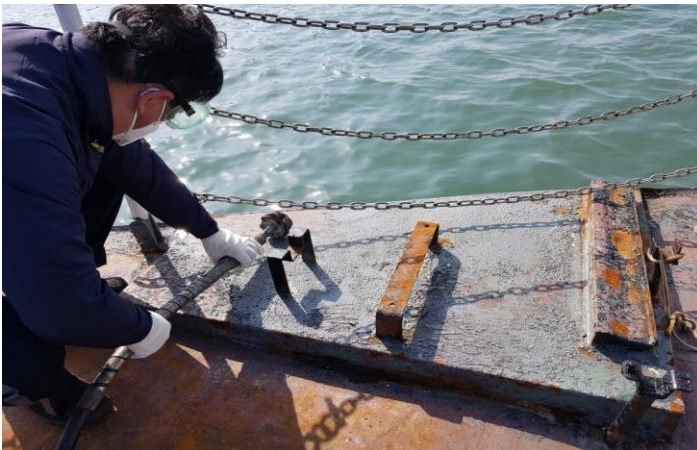
Removal of the existing coating

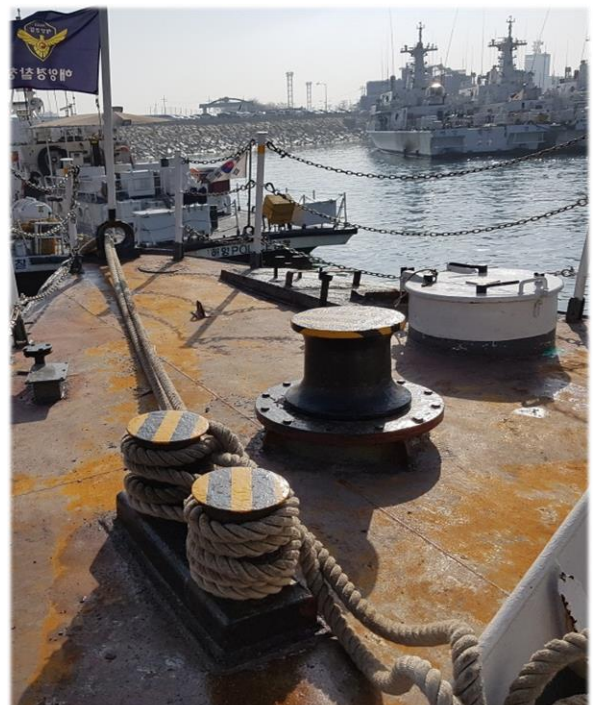
After removal of existing coating

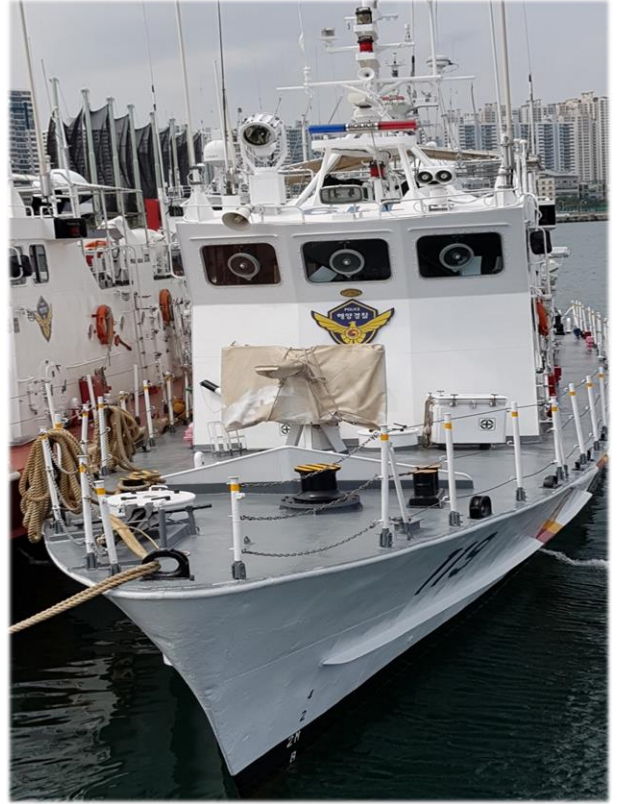
Application of **ZINGA**

Surface preparation: St 3

ZINGA 1 x 60 µm DFT

Vinyl Paint FS-26081

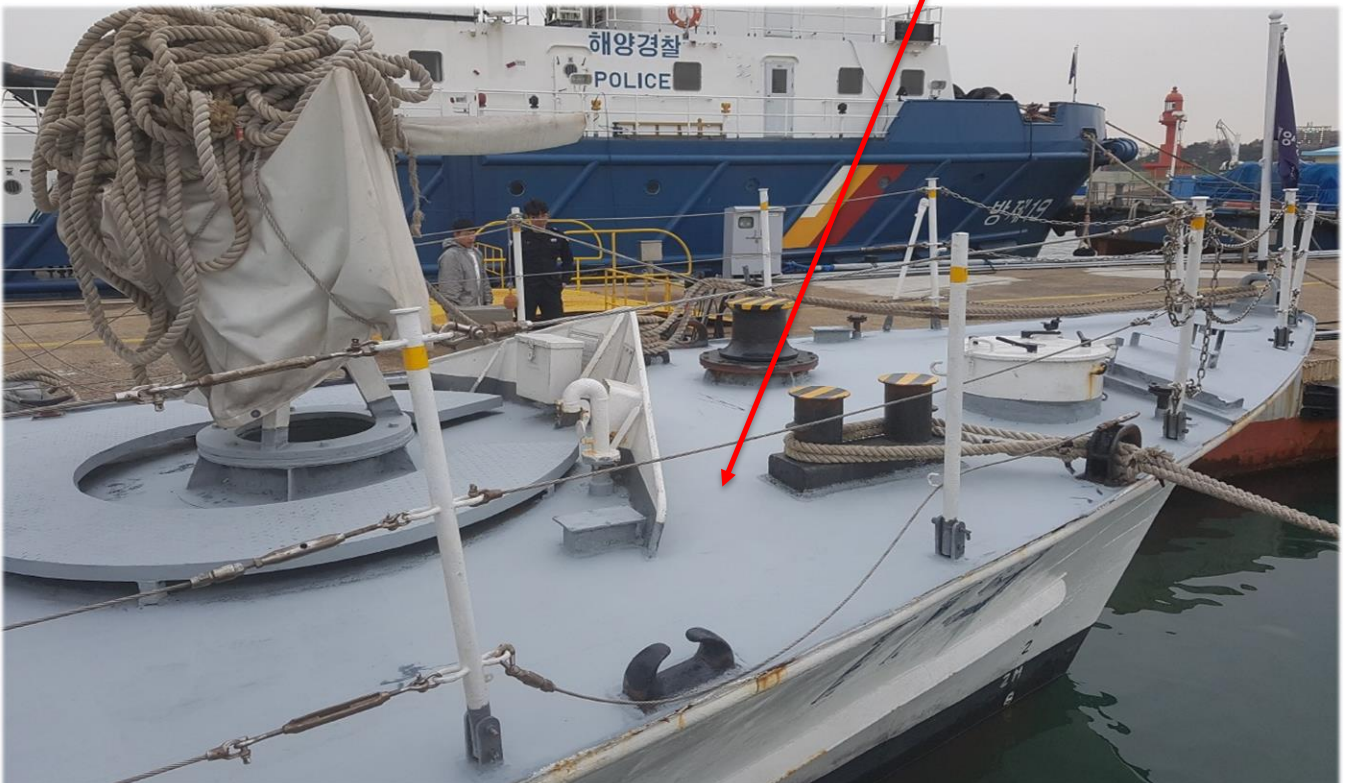
Final coat applied
