POTABLE WATER RESERVOIR – SAO PAULO – BRAZIL

In 2013, a potable water reservoir tower located near beach houses in Sao Paulo, was protected with **ZINGA**.

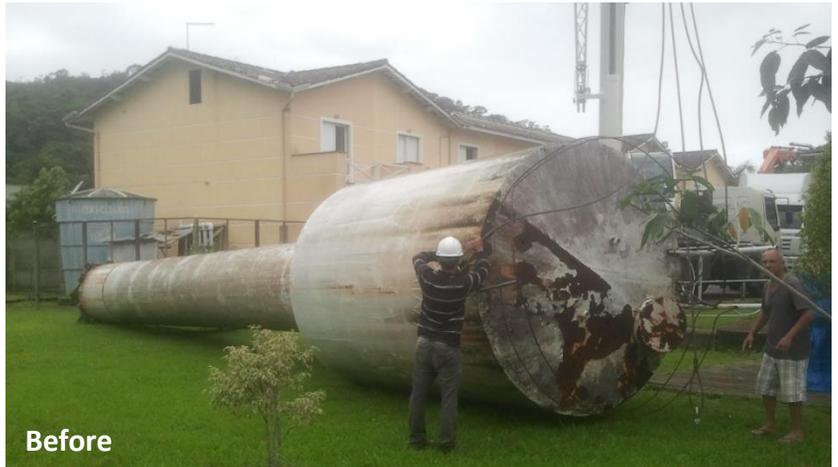
The water reservoirs were badly corroded. After dismantling of the towers, they were treated in a work shop. The surface was cleaned and blasted before a first application of **ZINGA**.

Before

The external **ZINGA** layer was overcoated with a UV resistant PU, the inside was overcoated with an epoxy suitable for contact with potable water.

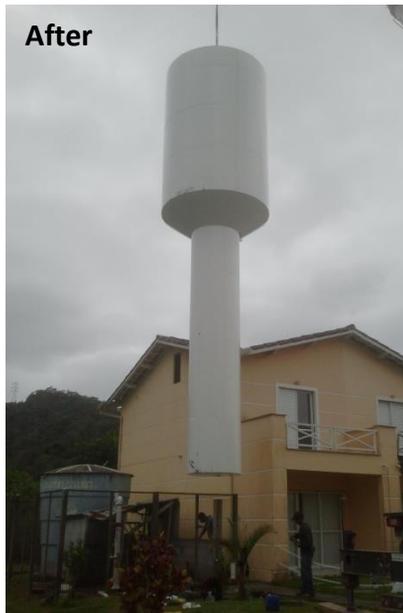
After

System:
 ZINGA 1 x 60 µm DFT
 + Epoxy topcoat (inside)
 + PU topcoat (outside)

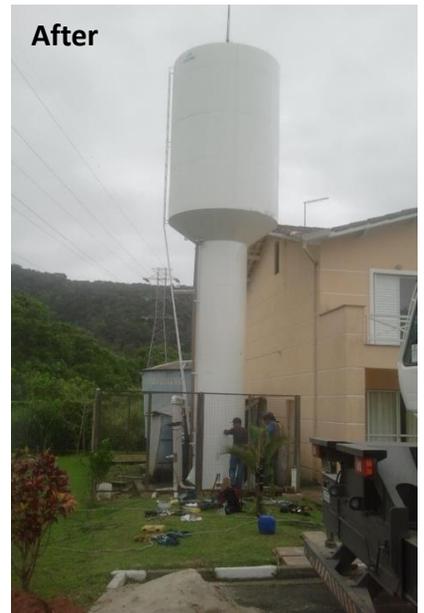
After

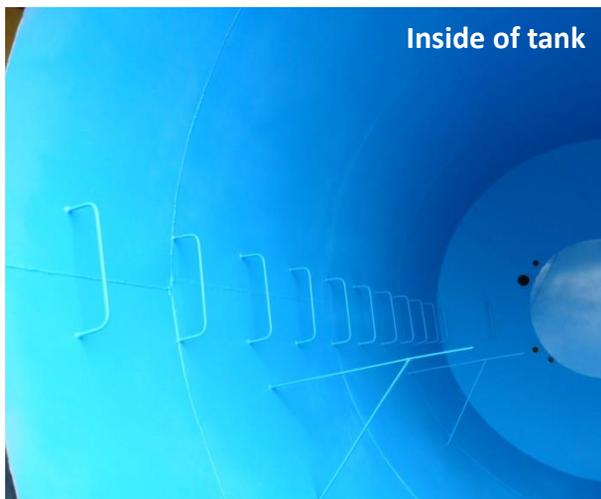
Inside of tank

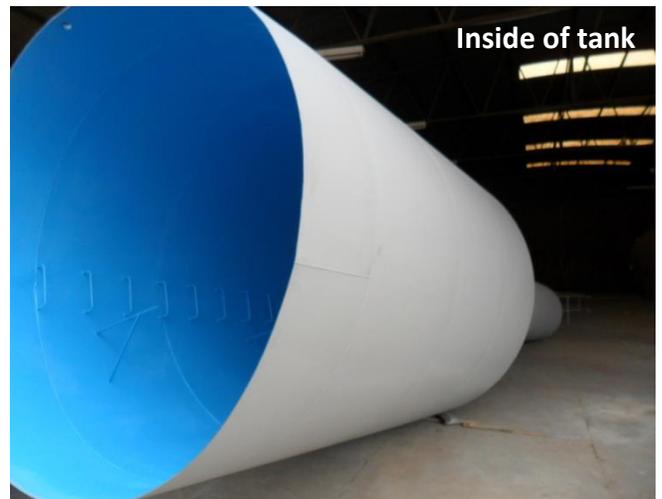
Inside of tank
